# Bute Town

# CONSERVATION AREA APPRAISAL & CONSERVATION AREA MANAGEMENT PLAN

Supplementary Planning Guidance to the LDP

Prepared March 2015

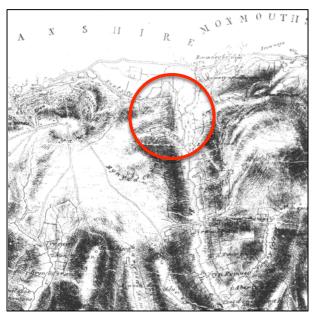
Extract of Manuscript OS Plan (1813)
Bute Town location highlights (not mapped)

The two inch manuscript OS plan dated 1813 clearly identifies the site of the Rumney Upper furnace, but there is no record of Bute Town. The first drawn record of Bute Town is the first edition One-inch Ordnance Survey Plan dated 1827, but published in 1832. This plan clearly shows the street layout of Butetown, although there are no buildings drawn.

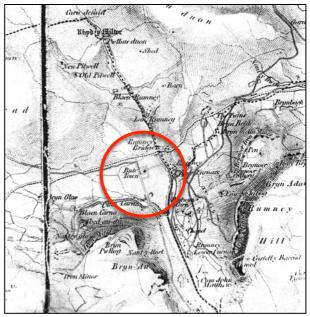
Extract of 2 inch manuscript OS plan (1827) Bute Town road layout identified

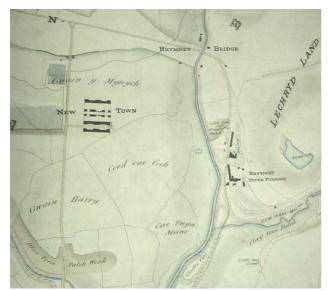
Extract of Surface Plan (1838)

The next drawn record of Butetown is the Surface Plan of .... the Property of Rhymney Iron Company, dated May 1838. This plan clearly shows the completed forms of three terraces, opposite the Rhymney Upper Furnace, and named 'New Town'. No plot divisions are drawn, but the outbuildings to the rear of Collins' and Middle Row are shown. One of these outbuildings may have been later converted from stables into the church.

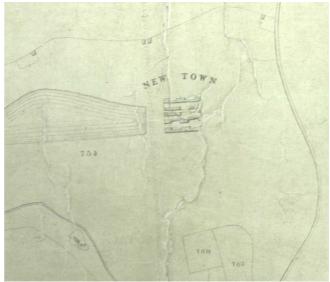
Extract of Tithe Plan (1842)

The Tithe Plan of The Parish of Gelligaer in the County of Glamorgan, dated 1842 clearly shows 'New Town' as three identical rows with outbuildings to the rear of Middle Row and Collins' Row. The apportionment to the tithe plan describes the plot as 'pasture', the landowner as the Marquis of Bute, and the occupier as 'The Rhymney Company'.

It is worth noting that the extent of the Rhymney Ironworks is much smaller on the 1842 Tithe Plan than it is on the 1838 Surface Plan. This might suggest that the drafters of Tithe Plan omitted some surface features.

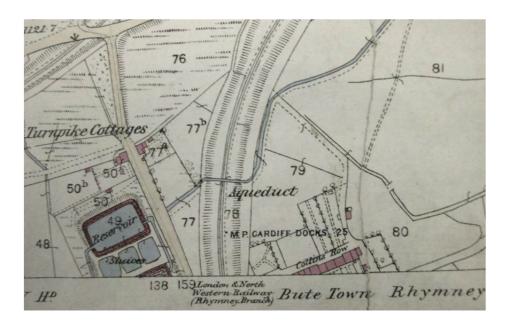
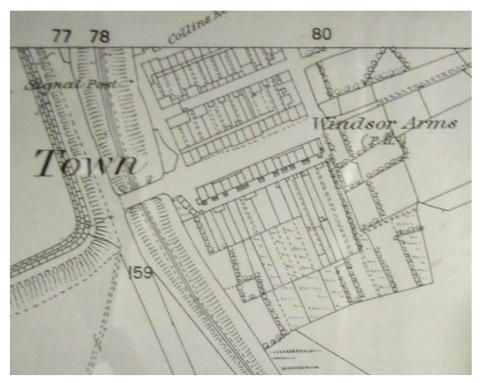
Extracts of OS Plans (1875)

The OS Plan First Edition dated 1875 shows well-defined external plots and internal party walls in their current arrangement. Windsor Arms Public House and Collins' Row are indicated, but the church is not shown. The London and North Western Railway, to the west of Bute Town, and the Rhymney brickworks had been constructed by this time.

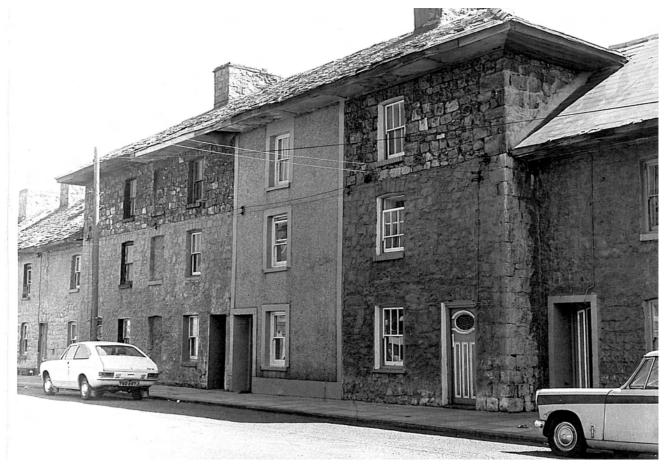
View of central section of Lower Row prior to 1970's restoration works Photo courtesy of CCBC

Other factors that had affected Bute Town's significance by this time included the demolition of the school occupying 15-16 Collins' Row and the construction of new dwellings immediately to the north of Bute Town. Both of these actions had a detrimental effect on the clarity of the original design.

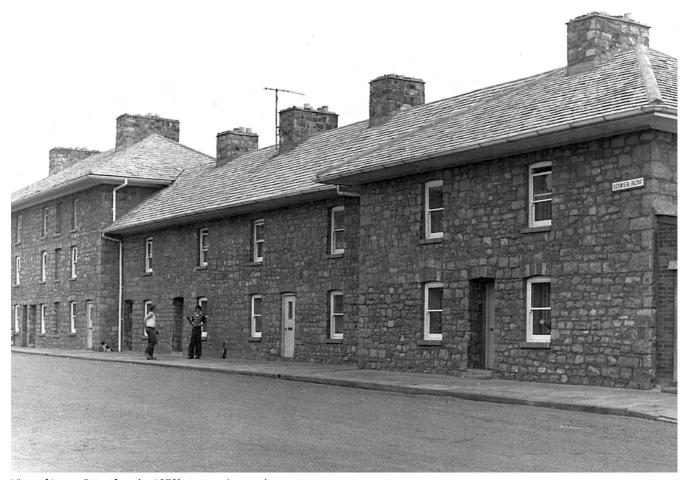
View of Lower Row after the 1970's restoration works Photo courtesy of CCBC

- New re-constituted 'stone' tiled roof coverings with associated timber roof structure repairs and re-building of some chimneys.
- Removal of applied finishes (pebble dash and lime-wash) to external walls by grit blasting and re-pointing.
- Standardising front windows with one-over-one horned timber box sash windows (It was decided not to reinstate cast iron windows).
- Standardising front doors as timber boarded doors with small glazed apertures.

Whilst the works were successful in creating a much more unified appearance to Bute Town, the standard of some of the work was poor. Some chimneys were poorly re-built and roof defects became apparent shortly after the works were completed.

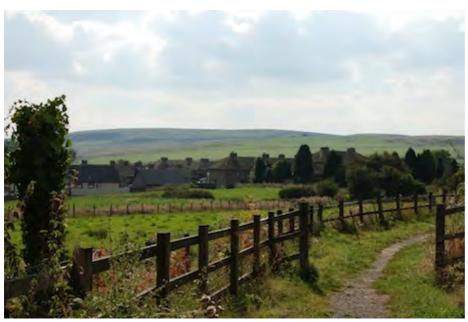
Views of the Conservation Area from further afield are essentially modest roofscape views, where one has to work to pick out the collective as the muted tones of the pointed stonework and weathered roof materials seem to blend into the surrounding exposed and windswept landscape.

View into the Conservation Area from the North

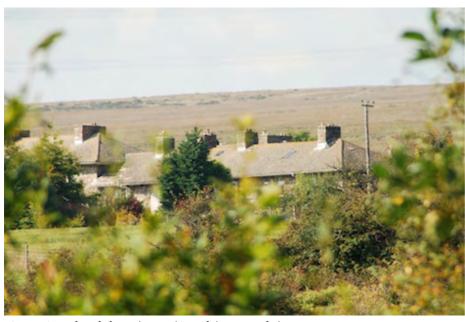
Distant view of roofs from the outskirts of the town of Rhymney

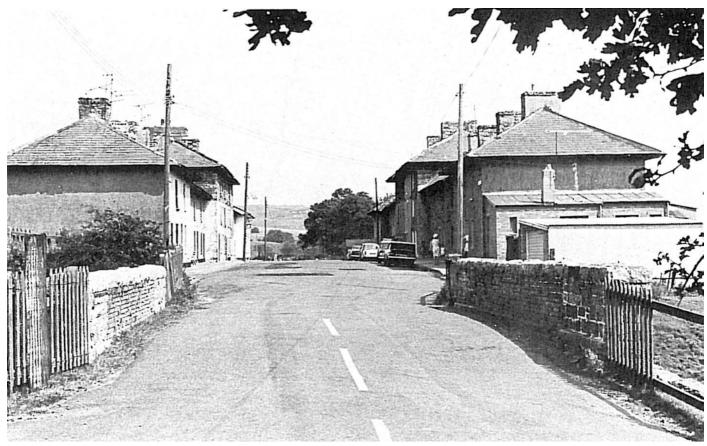
Entrance to Bute Town prior to 1970's refurbishment works, via bridge over the railway (now removed)

Recommendation: Consider redesigning the entrance to Bute Town to more closely resemble the previous arrangement based on historic / photographic evidence.

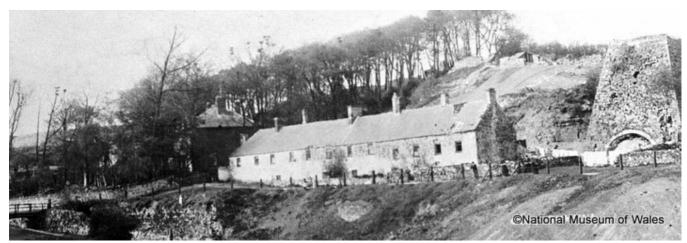
Historic view of Union Ironworks with the manager's house (now the Rhymney House Hotel) in the background and furnace to right hand side. The terraced row of houses has been demolished.

The visual link between the site of the old ironworks and Bute Town are particularly evocative with the old manager's house (Rhymney House Hotel) clearly visible from several critical locations, though more appreciation of this link should be provided with interpretation about the missing furnace.
