## Sewerage Briefing Paper (Sent to Members on 26<sup>TH</sup> February 2021)

### Historic Flooding and Sewerage Issues at the Sue Noake ATP

### **Manhole surcharge at the site of the proposed new pitch SN2**

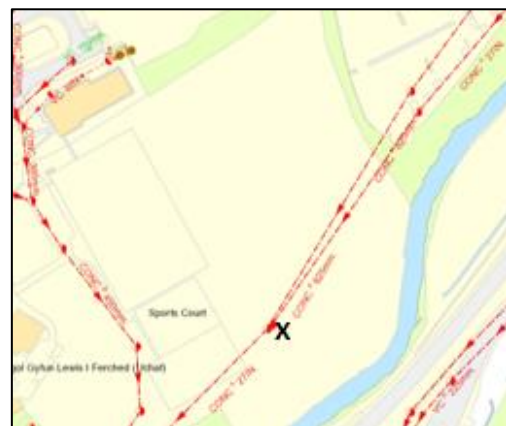
Two manholes (located alongside X in the diagram below) sit above a mainline or trunk sewer and are the responsibility of Welsh Water.

Welsh Water have confirmed that their own records indicate that there have only been two recorded incidents of the manholes shown at X surcharging over the previous ten years. The first of these was in 2014 and the second, the most recent incident, in January 2021. Discussions with Welsh Water this week confirm this to still be the case.

When a breach of this nature occurs, particularly on a trunk sewer, Welsh Water have a number of specific responsibilities. These can be summarised as site containment, decontamination, reinstating the manholes, investigation and remediation.

With regard to the breach at Sue Noake, the area of the surcharge has been cordoned off by Welsh Water (site containment) to enable the elements to begin naturally breaking down any waste material (decontamination). The manholes have also been reinstated.

Welsh Water have begun a detailed investigation of the breach and will return to site this week to continue to explore both upstream and downstream using specialist camera equipment. This will enable Welsh Water to identify the cause and prescribe the necessary remedial action to clear the system and protect against future breaches.

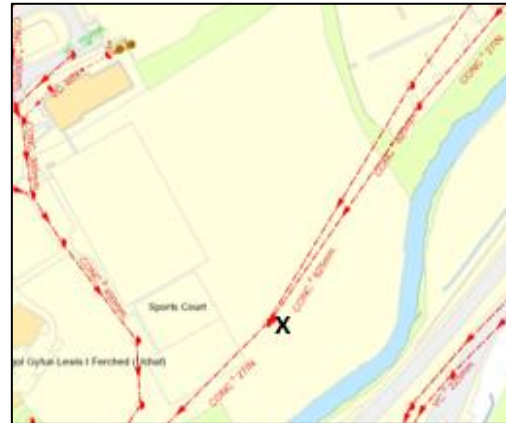
The likelihood of a reoccurrence of the recent surcharge of the manholes at **X** is considered unlikely and the frequency of reports over the last decade would appear to support this position.

The Council will make an application to Welsh Water to relocate the manholes further away from the pitch.

In the interim the Council is also exploring as part of its plans for SN2 the possibility of developing a protective 'bund' around the manholes. A 'bund', essentially, a raised grass bank will be installed between the pitch and the manholes to provide additional protections to the new pitch from any debris that may emerge should the manholes surcharge again at a future point.
